787

Flight Crew Operations Manual Bulletins Ethiopian Airlines Corporation

Bulletin Package Revision: 12D
Bulletin Package Date: June 8, 2016

This Bulletin Package is an Addendum to:
Document Number: D615Z003-ETH
Revision Number: 12
Revision Date: March 21, 2016

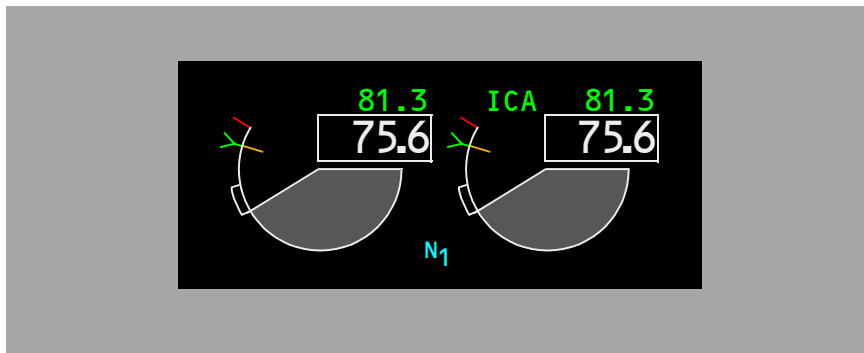
Ice Crystal Anti-Ice Indication (ICA)

Displayed (green):

- ice crystal anti-ice function is on
- ice crystal icing conditions may not be present

Ice Crystal Anti-Ice (ICA) is an automatic feature that provides engine protection against ice crystal icing (ICI). The ICA function activates only above 30,000 feet. The ICA function activates for at least 30 minutes and may continue in additional 15 minute increments, for as long as ICI conditions are encountered. If the airplane descends below 28,500 feet the ICA function terminates.

An ICA indication does not mean that the engine is currently encountering ICI conditions. After engine maintenance activities, for example after an engine change or an EEC change, the ICA indication can show in cruise flight, in any weather conditions, for 75 minutes or more.
